MAINTENANCE GUIDE EASYLIFT PREMIUM

The Easylift Premium is extremely robust, thanks to the materials used to construct them. These materials also require a minimum of maintenance, and one annual inspection is generally enough to ensure that they are functioning correctly. VelopA has compiled this maintenance manual for that purpose.

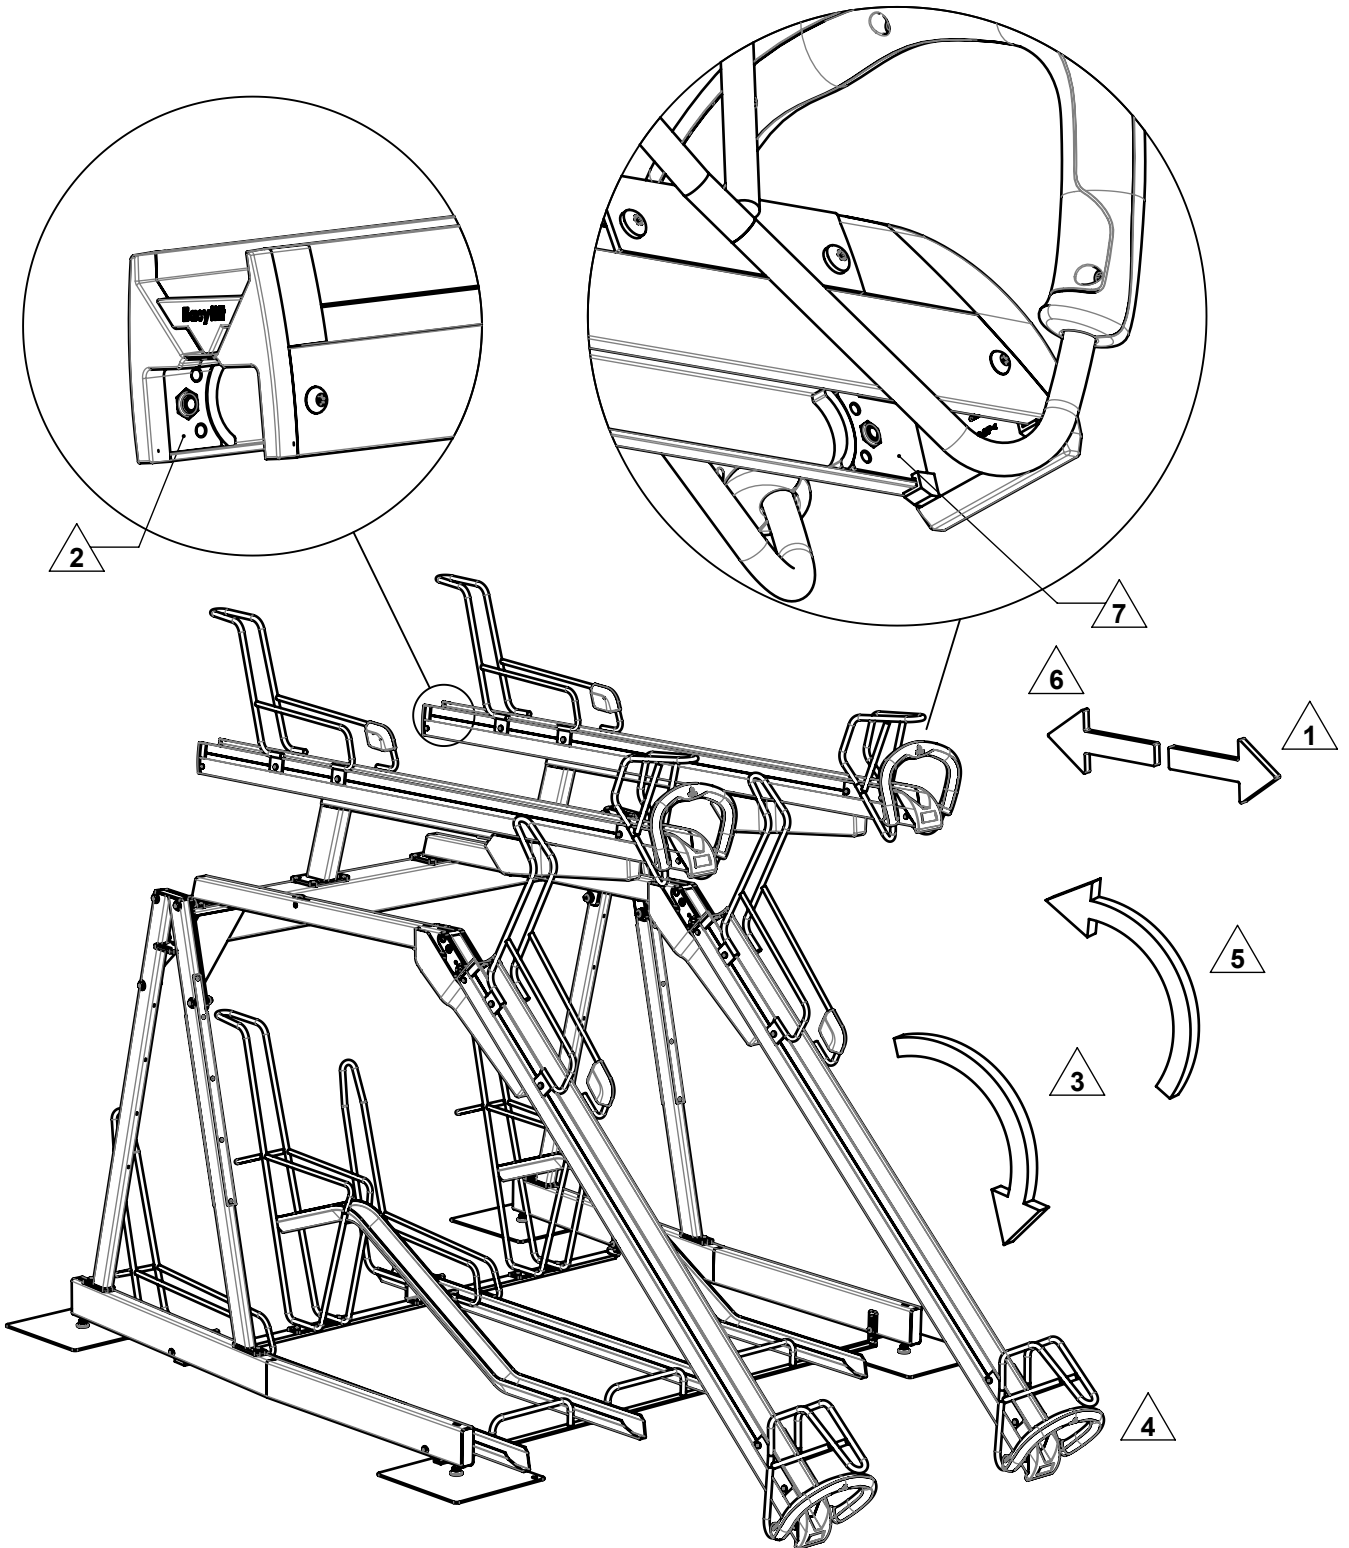
Laatste controle / Vérification finale / Endkontrolle / Final check

1. Hoek van 2° is benodigd voor afwatering en dient tevens als uitrolbeveiliging
1. Winkel von 2° wird für die Entwässerung benötigt und dient auch als Rückrollsicherung
1. Un angle de 2° est indispensable pour les écoulements d'eau et le maintien du vélo
1. Angle of 2° is needed for drainage and also serves as roll out security
